# Reference Plant

## Biomass Boiler Silbitz / DE

# Biomass Boiler Silbitz: pictures of furnace walls before and after installation of SPG

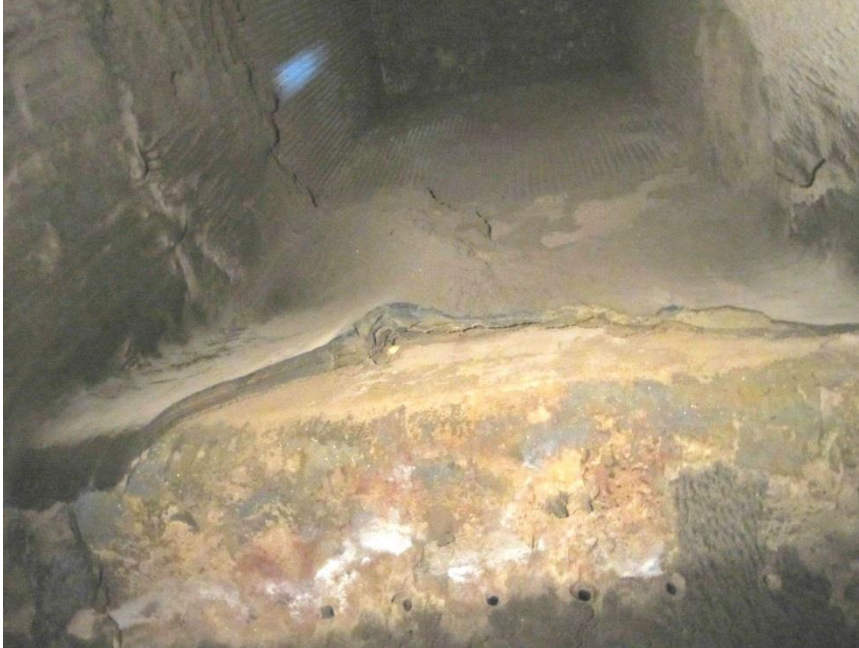
Before installation of Shock Pulse Generator:  
Year 2010, after 10 weeks of boiler operation

Large slagging / deposits are visible at the membrane walls and at the refractory.

Several times, large size slag lunks were falling down after some time due to heavy weight and blocked the deslagger or damaged the stoker

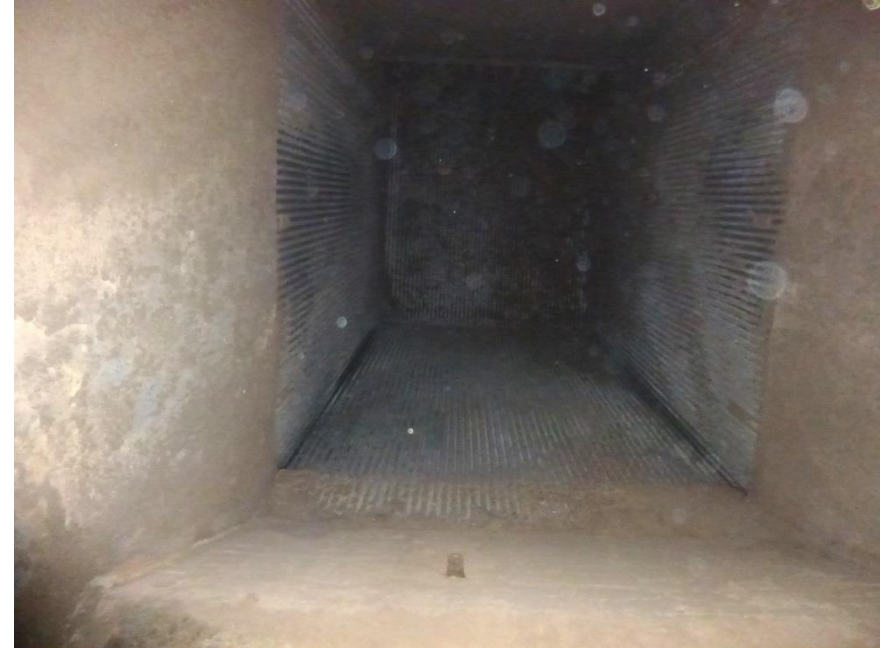
After installation of the Shock Pulse Generator:  
Year 2015, after 12 weeks of operation

Slag and deposits are cleaned off from membrane wall and from refractory by the Shock Pulses of the SPG.

There were no further blockages of the deslagger, nor damages to the stoker.
