## CLEANING FIN TUBES IN HRSG BOILERS

Bang&Clean Technologies AG  
licenses Pressure Wave Technology  
to its Technology Partners KRR  
ProStream in the UK and Detoclean  
in the Netherlands

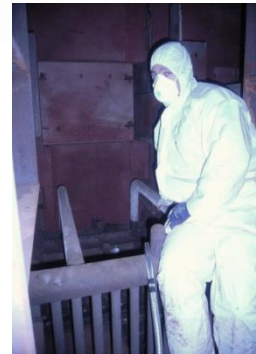
**Above and Below:** The flexi-lance is lowered into the area to be cleaned, and then the pressure wave is actuated

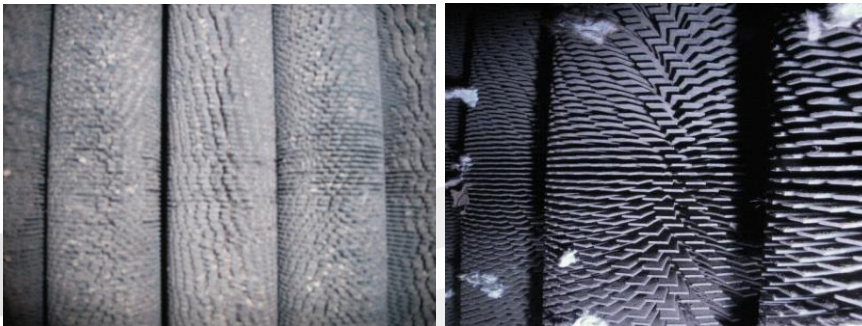
**Above left:** Fouled fin tubes after a years' operation before cleaning  
**Above Right:** Fin tubes after cleaning using Pressure Wave Technology
